ASB-1049

## Service Bulletin

**Subject:** TS-850S "Click Noise" with Notch On

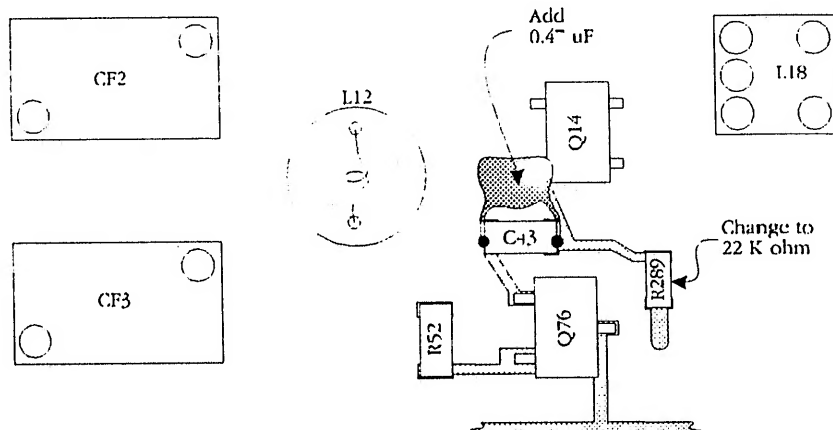
X48-3080-00 Foil Side View

When a strong signal of S-9 or greater is received at the antenna terminal with the NOTCH circuit ON a "clicking" noise might be noticed. This is caused by excessive response in the AGC loop circuit.

The changes detailed below will add additional delay to the AGC circuit and reduce or eliminate this tendency.

Qty	Description	Old Part No.	New Part No.	Circuit Description
1	22 k Ohm chip resistor	RK73FB2A103J	RK73FB2A223J	R289
1	0.47 uF capacitor	NA	CQ92M1H474K	NA
